## The Heathrow Tunnel Collapse

Prof. Chris Clayton

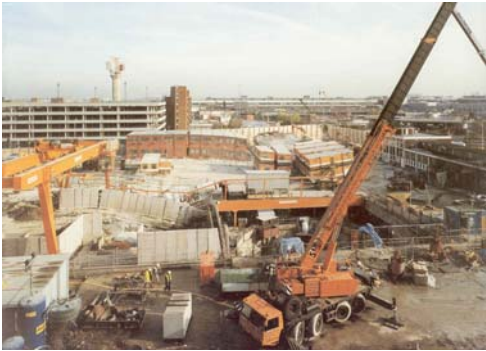
### Central Terminal Area after collapse

Fuel depot Shaft looking NE from Terminal 3 Car Park

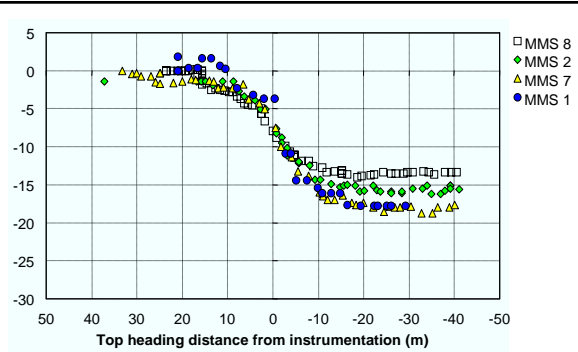
Settlements over the T4 concourse and downline platform
